Profiling for successful BGA/CSP Rework

This paper discusses how to successfully profile a printed circuit board when reworking Ball Grid Array and Chip Scale Packages.

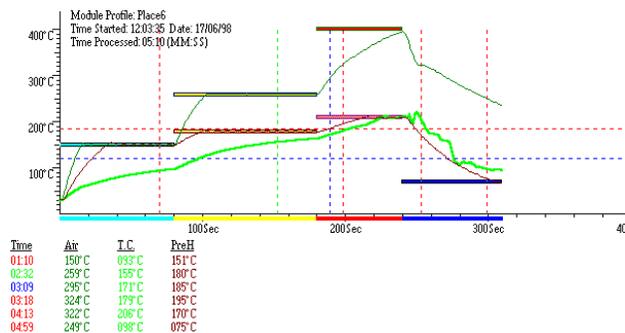
The graph below shows a trace of a profile taken from under a 492 PBGA on a PC motherboard where the thermocouple trace appears to be normal – hitting the desired pre-heat, soak and reflow temperatures.

In this case with either solder paste or flux, a very low pass rate was achieved.

The route of the yield problems was due to the plastic BGA warping during reflow. An excessive source temperature on the topside of the PCB caused this.

The second graph shown is the final profile that was used, and as you can see, the 2 traces are very similar but the heating has been done in a totally different way. In this case, we have increased the number of zones to 4, reduced the top air temperature significantly while increasing the underboard heat to the whole board and utilizing an underboard centralized heating zone.

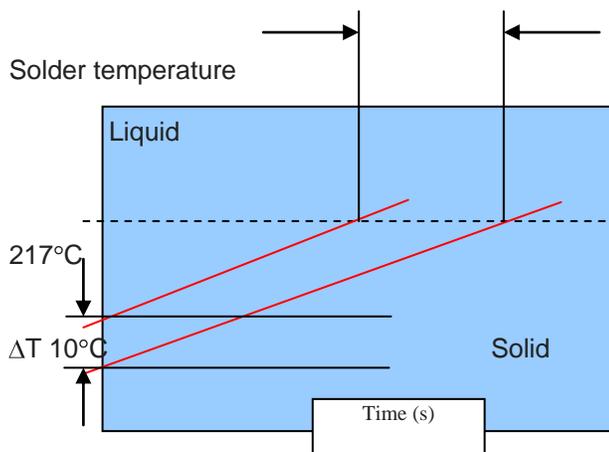
Graph of ramp rate at $0.5^\circ\text{C}/\text{Sec}$

Example – Reflow input temperature too low

The following diagram shows a graph section of a components’ solder joints going from solid to liquid at a melting temperature of 217°C . We are assuming that the achieved ΔT across the component is 10°C .

The rate of temperature rise (ramp rate) will determine the duration of reflow from start to finish. This is directly proportional to the input temperatures set on the profile. In this case the ramp rate is 0.5°C per second.

Total time to achieve reflow 20 seconds

The solution would involve changing the profile input- temperatures to achieve a higher ramp rate. This would in turn produce a more simultaneous reflow as illustrated in the graph below.

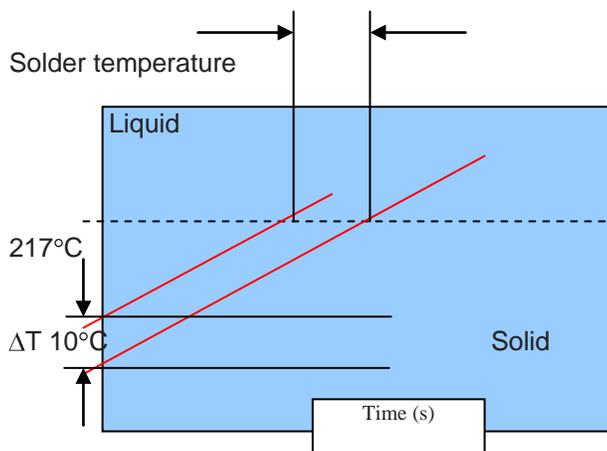
Graph of ramp rate at 2.5°C/Sec

Total time to achieve reflow 4 seconds
